# ShoreTel 12.1 GA Version 17.21.9592.0

## Software Release Notice (Build Notes)

Release 17.21.9592.0 is a GA build of ShoreTel 12.1.

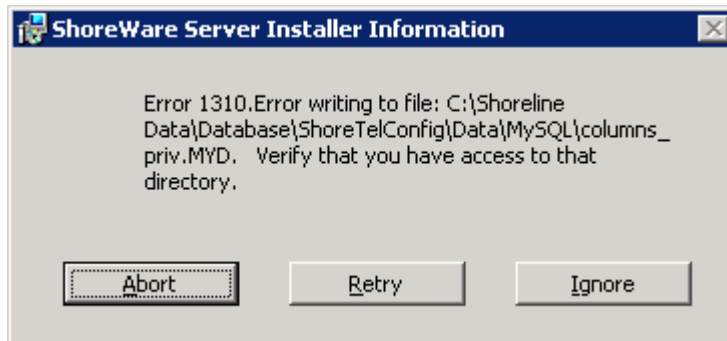
4. Defect 1-72081584 (See KB16486) — Sites at risk are those on ST12 build 17.10.1730.0 or greater that are upgrading to the next higher build. Once sites have upgraded to this build, 17.21.9592.0 they are no longer at risk for this issue. These sites may encounter the following error message which will halt the upgrade:

### Cause:

ShoreTel-MYSQLConfig service is started in the Service Control Manager.

**Recovery:**

1. Do not click the “Abort, Retry or Ignore” buttons on the “ShoreWare Server Installer Information” dialog window above
2. Press Alt + Tab to access the “Start” Button
3. Open Start > Settings > Control Panel > Administrative tools > Services (for a 2003 system) **OR** Start > Control Panel > Administrative Tools > Services (for a 2008 system).
4. Look for the ShoreTel-MYSQLConfig service
5. Right click on the service and click stop
6. Verify if the ShoreTel-MYSQLConfig service has stopped
7. Go back to the aforementioned ShoreTel Installer dialog box
8. Click on the “Retry” button on the installer dialog to continue with the installation.

Note: If you happen to click abort or ignore, the system will roll back and should recover back to its previous state where you can reattempt the upgrade.
